LANDSLIDES AND RELATED FEATURES OF THE SPARTA, TENN. QUADRANGLE

by
Roger E. Thomas
1981

U.S. Geological Survey
OPEN FILE MAP 81-1318 (H-5)

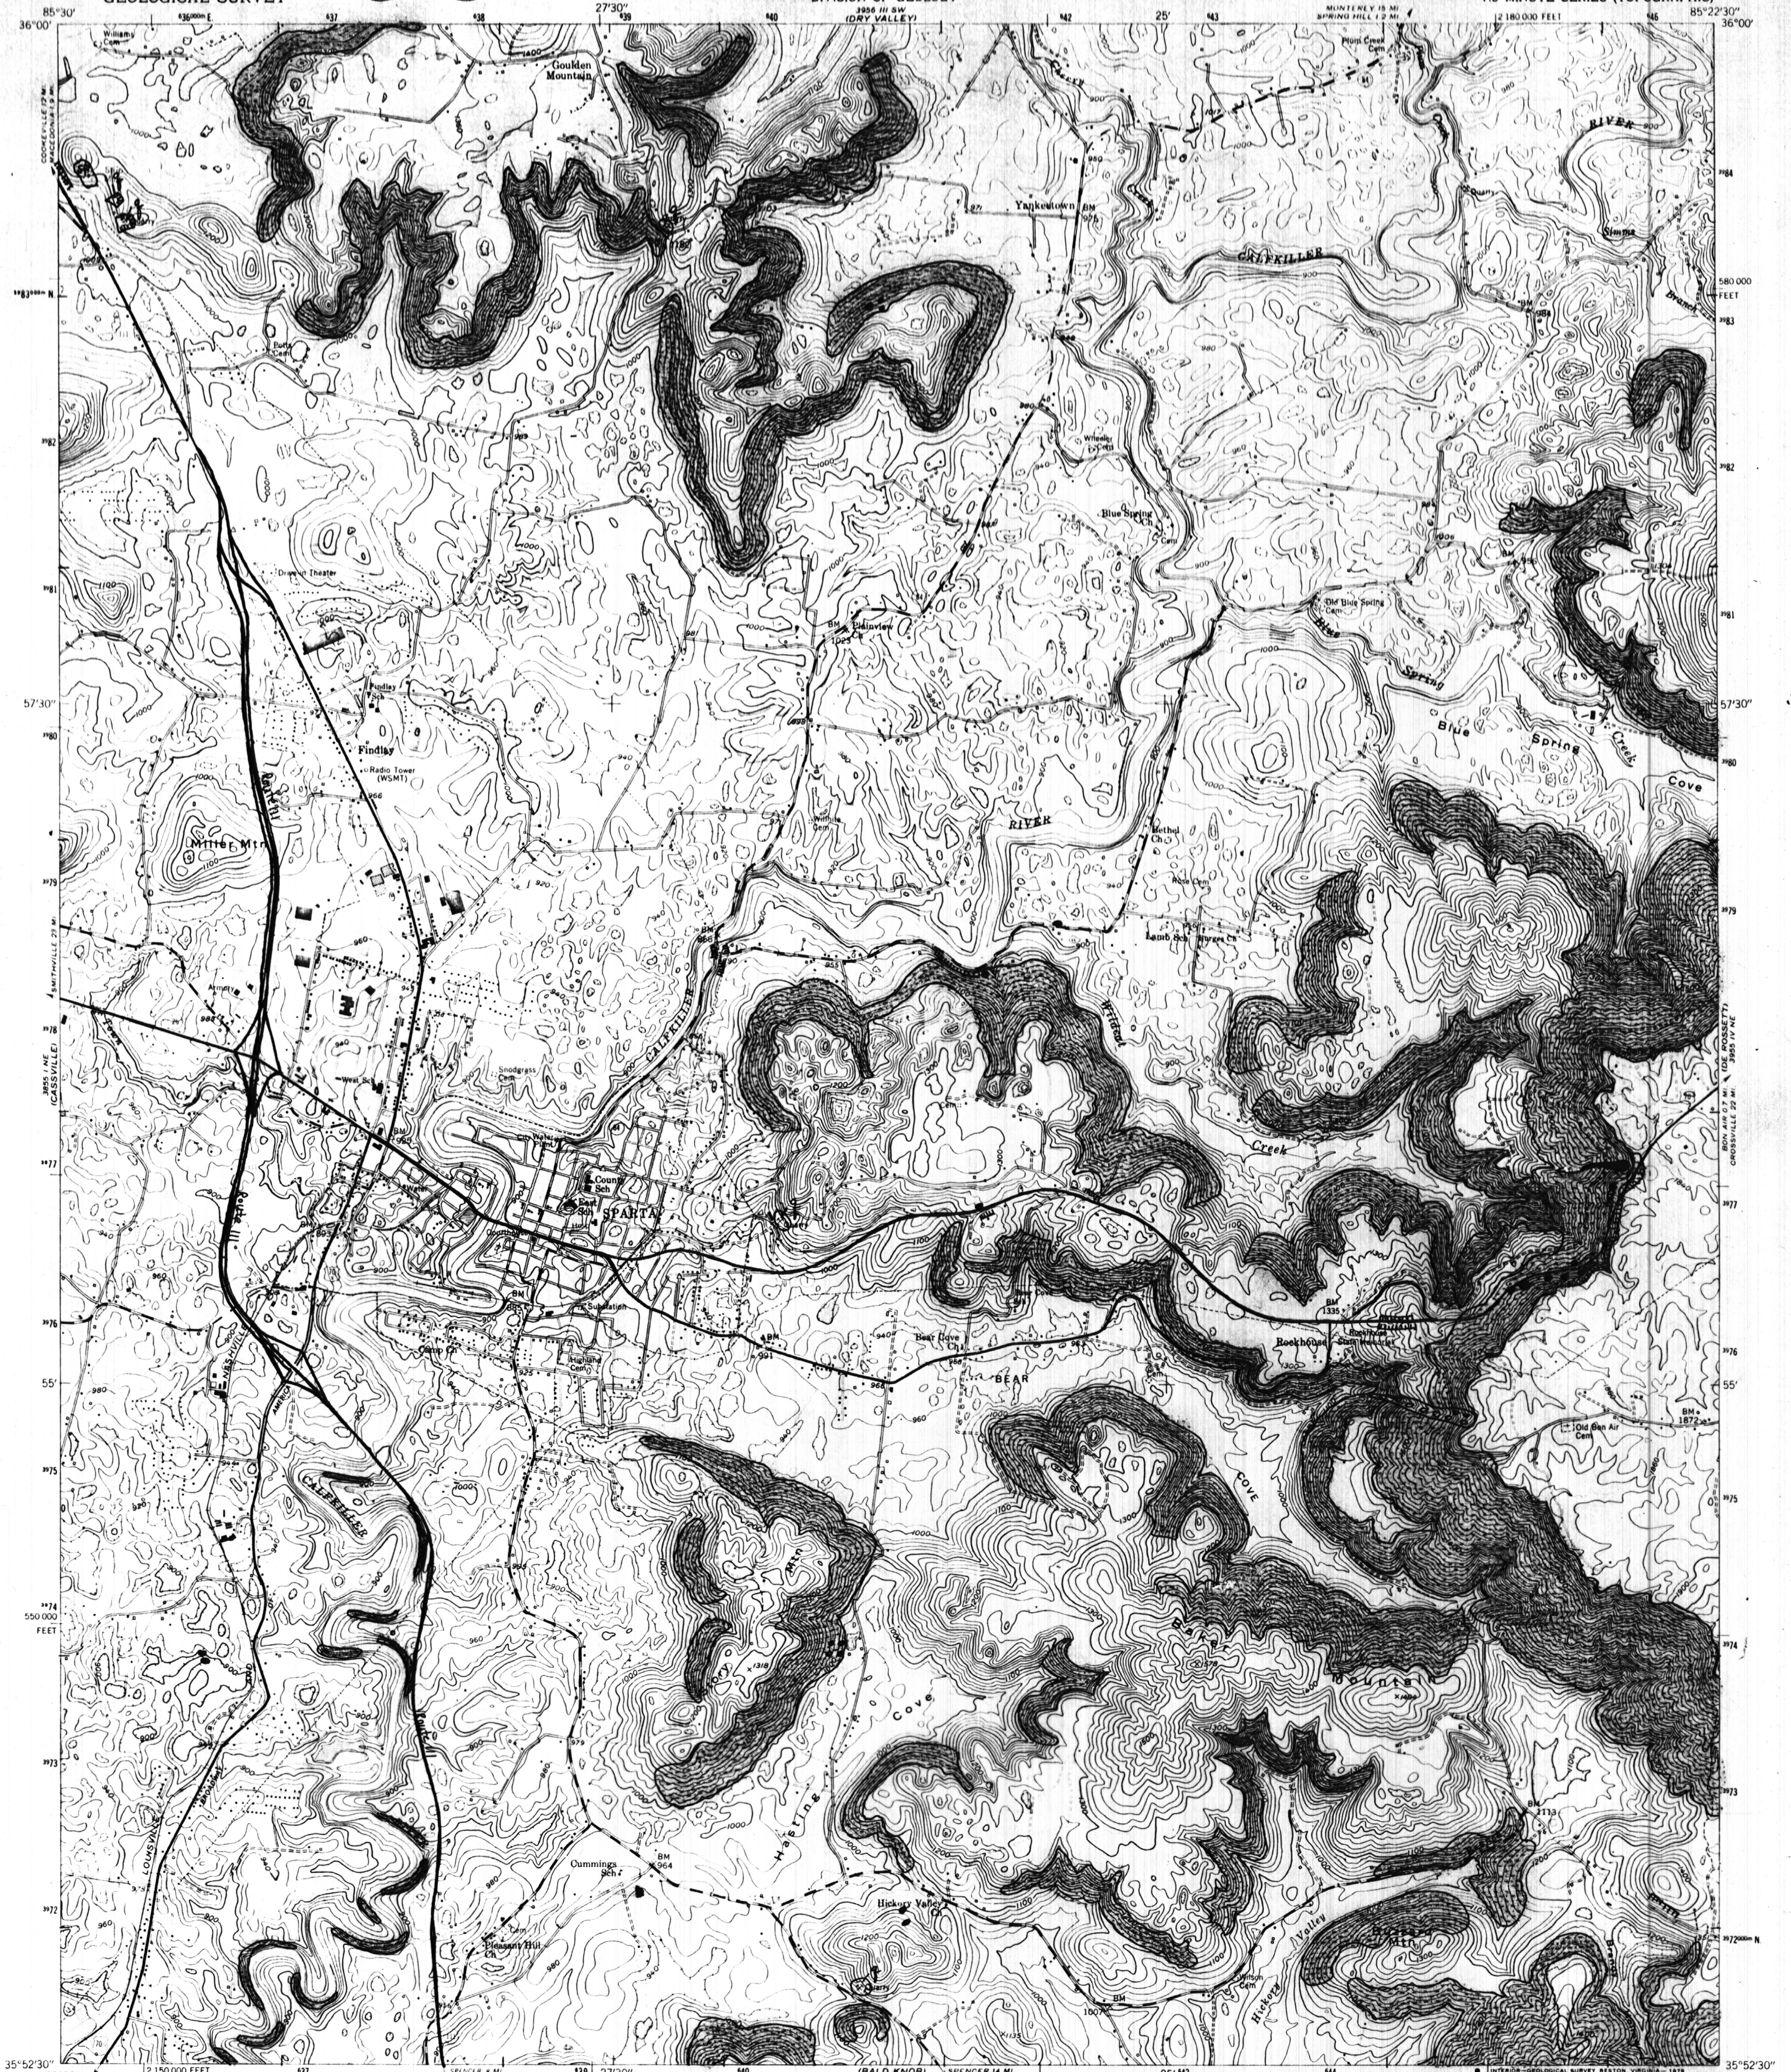
Landslides and related features interpreted
from aerial photographs:
1:40,000 (Black and White) 1979
1:79,000 (Black and White) 1976

Photointerpretation and field check 1981
This report is preliminary and has not
been reviewed for conformity with U.S.
Geological Survey editorial standards.
